**East Kapolei Affordable Housing Project
Kapolei, Oahu, Hawaii**

FINAL SITE ASSESSMENT REPORT

December 12, 2007

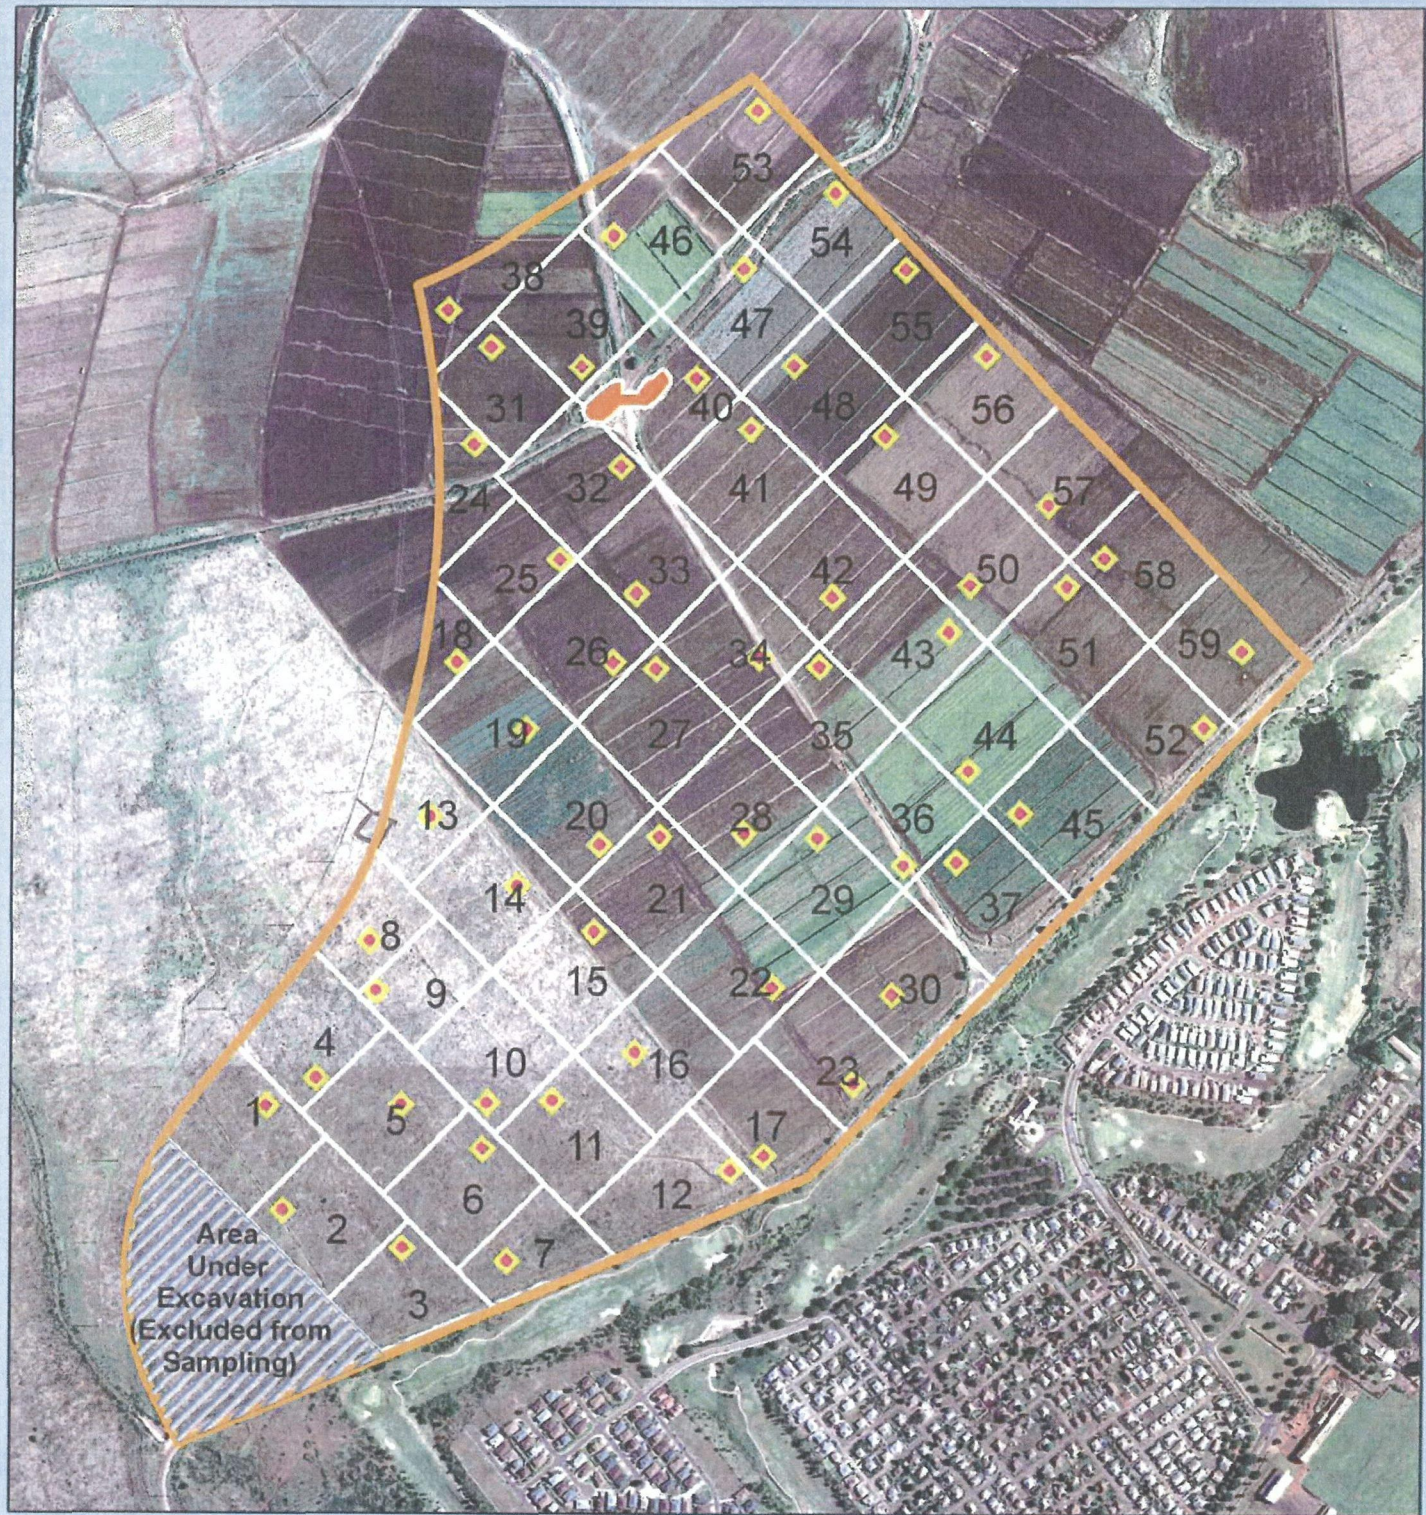
FIGURE 3

- Center of Decision Units
- Decision Units
- Decision Grids
- Pesticide Mixing and Loading Area and Potential Contamination Area
- Site Boundary

The result was 59 decision units located in a stratified random pattern throughout the entire site. Figure 3 presents the distribution of the decision grids, decision units, and center points of the decision units across the project area. Special consideration was made to those decision units which were located within or near the boundaries of the CRA. The latitude and longitude coordinates of the center point of each decision unit was loaded into a global positioning system (GPS) unit for use in the field. The coordinates are presented in Appendix B.

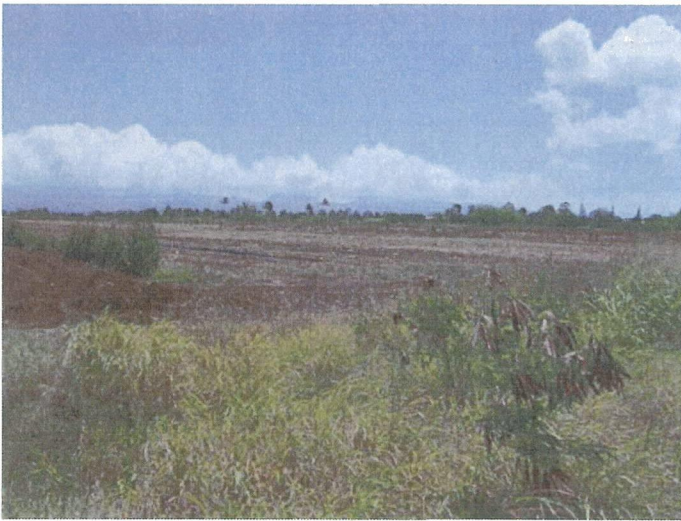
Photograph 2

View facing southeast across an example of recently harvested agricultural fields located on the project site.

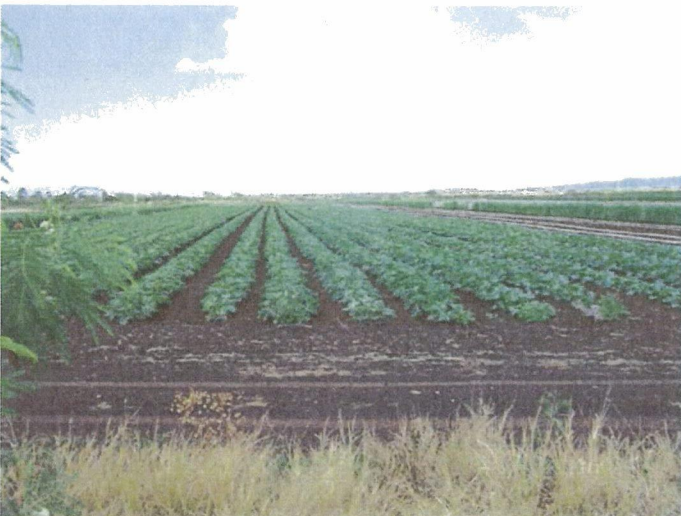
Photograph 3

View facing west toward an example of active agricultural fields on the project site.

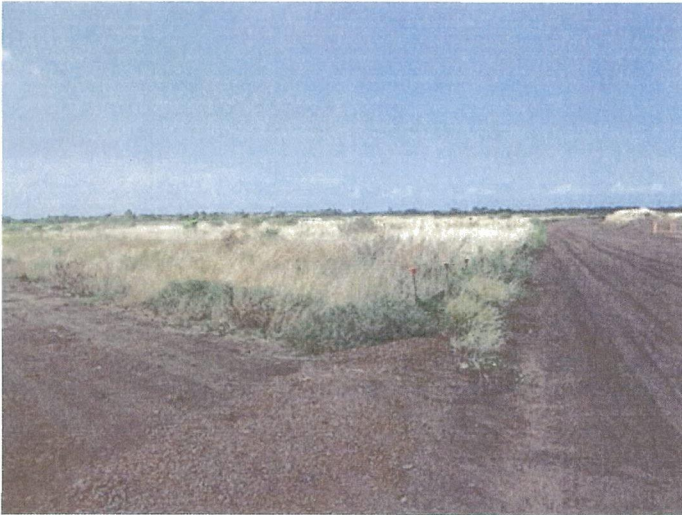
Photograph 4

View facing southwest toward an example of fallow, undeveloped land located on the western portion of the project area.

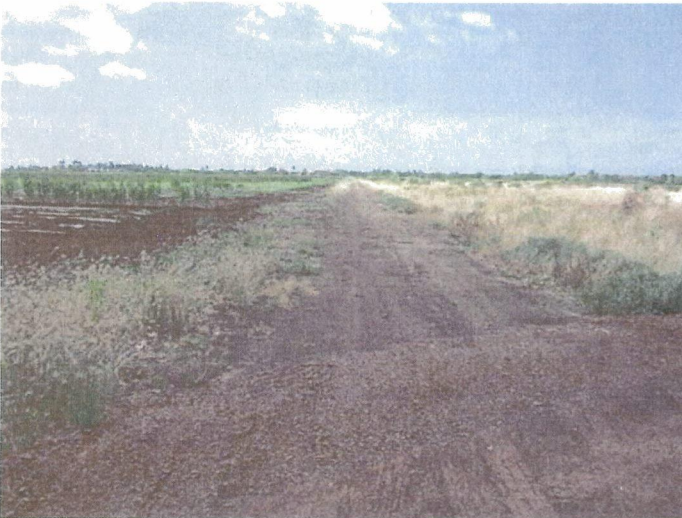
Photograph 5

View facing south down an unimproved access road separating active agricultural fields to the left and fallow, undeveloped land to the right.

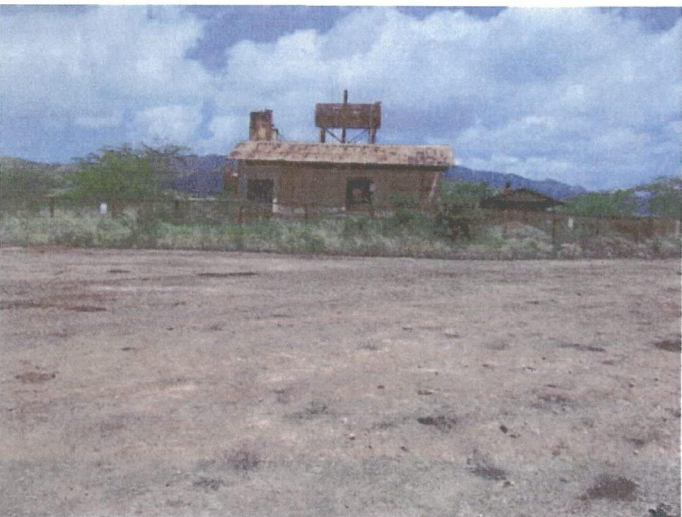
Photograph 6

View facing north toward the Oahu Sugar Company Pesticide Mixing and Loading Area.

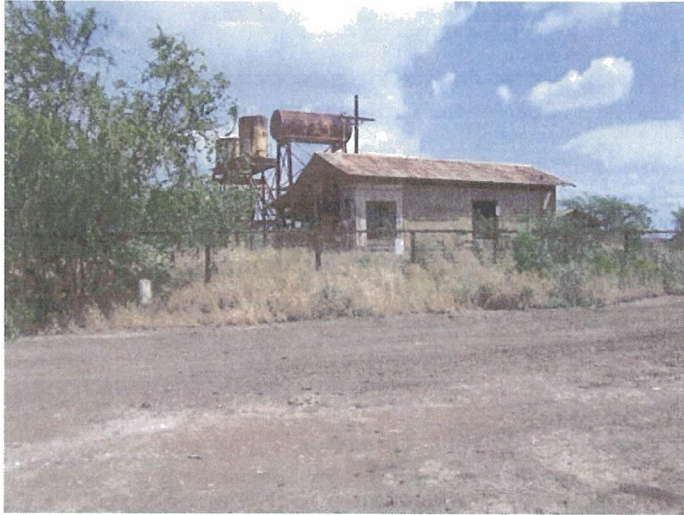
Photograph 7

View facing north toward the Oahu Sugar Company Pesticide Mixing and Loading Area.

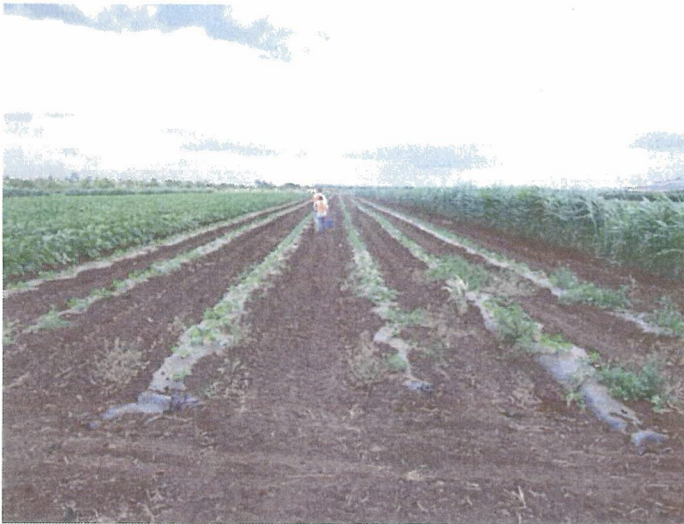
Photograph 8

Tetra Tech field team crossing agricultural fields and locating a decision unit center point using a portable global positioning system (GPS) unit.

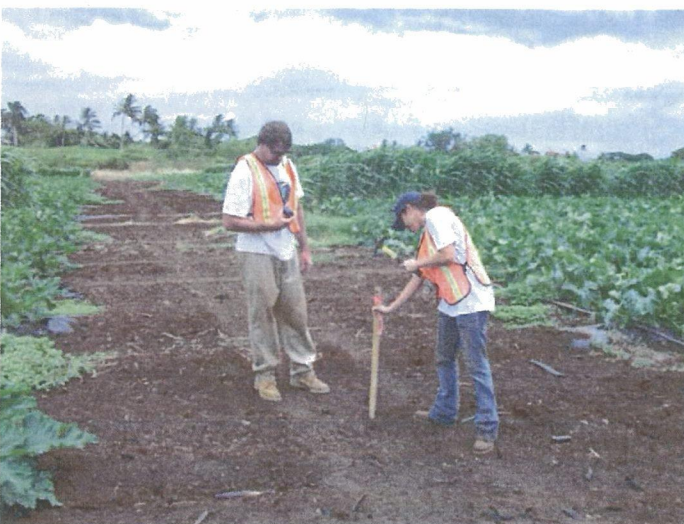
Photograph 9

Field team marking the center point of a decision unit.

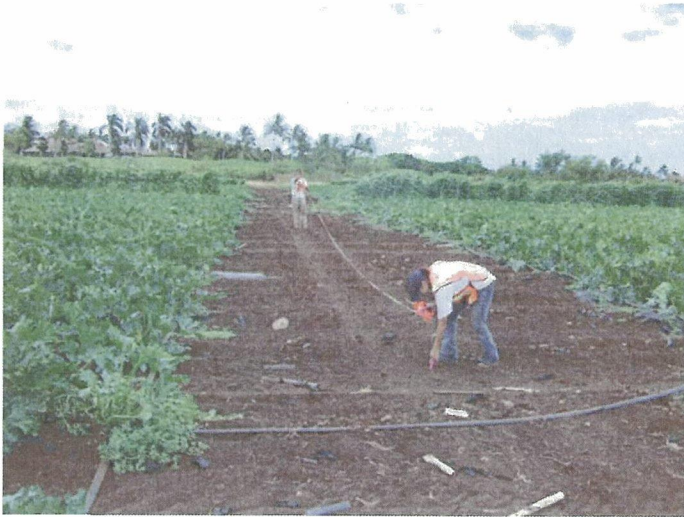
Photograph 10

Marking the corner point of a decision unit. One field team member used a compass to direct a second field team member to the north, east, south, and west corner points. A measuring tape was used to measure approximately 35 feet from the center point to each corner creating an approximately 5,000 square foot decision unit.

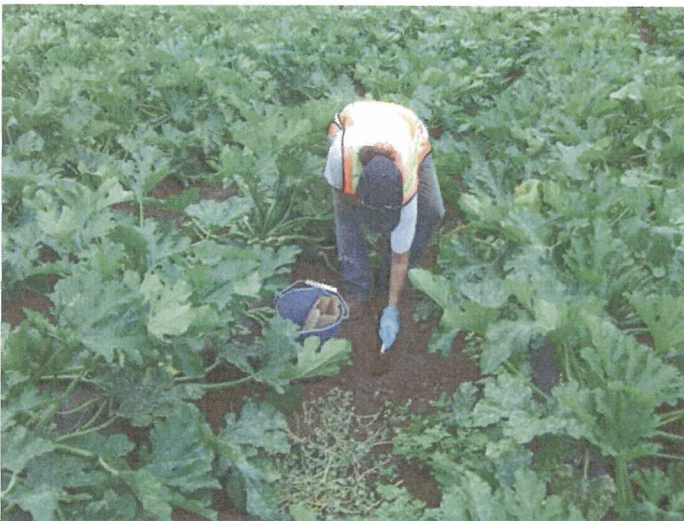
Photograph 11

Collection of incremental sample within a decision unit. Soil was collected approximately 1 to 2 inches below the ground surface using a stainless steel spoon. Collected incremental soil samples were placed into a disposable paper bag.

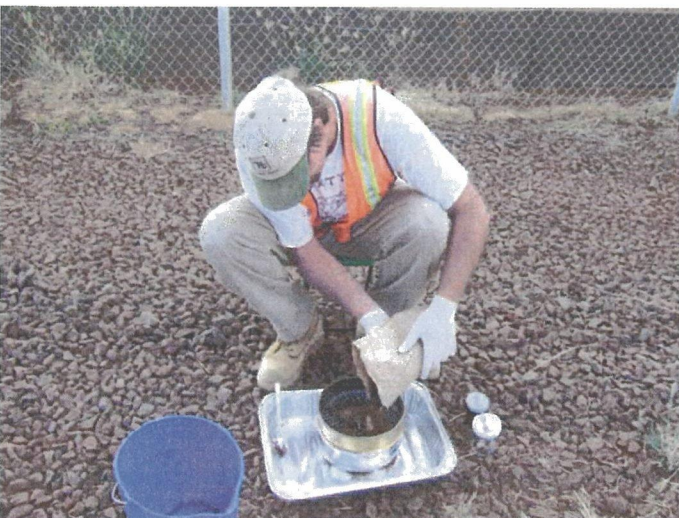
Photograph 12

Field team member sieving collected soil through a #10 sieve into a disposable aluminum pan. The #10 sieve is silver and located below the brass sieve in the photograph.

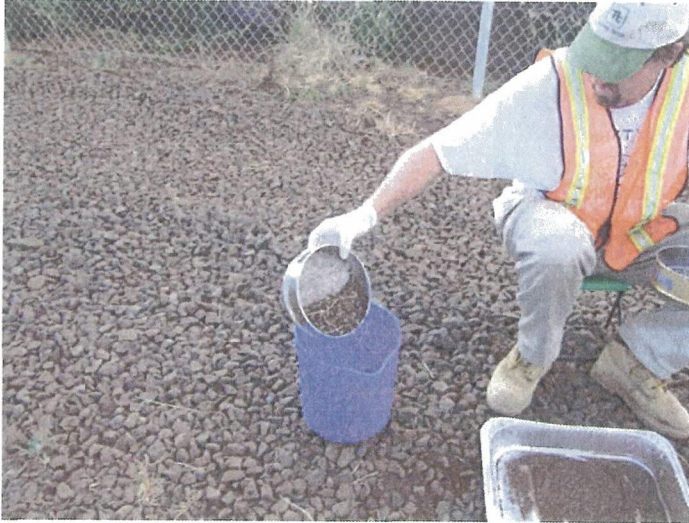
Photograph 13

Material larger than the #10 sieve size was placed into a separate container for later return to the decision unit of origin.
